Cyclic tests of engineered shear walls with different bottom plate and anchor bolt washer sizes (Phase II)

Rakesh Gupta, Associate Professor
Heather Redler, Graduate Research Assistant
Milo Clauson, Faculty Research Assistant

Department of Wood Science and Engineering
Oregon State University
Corvallis, OR 97331

American Forest & Paper Association
Washington, DC

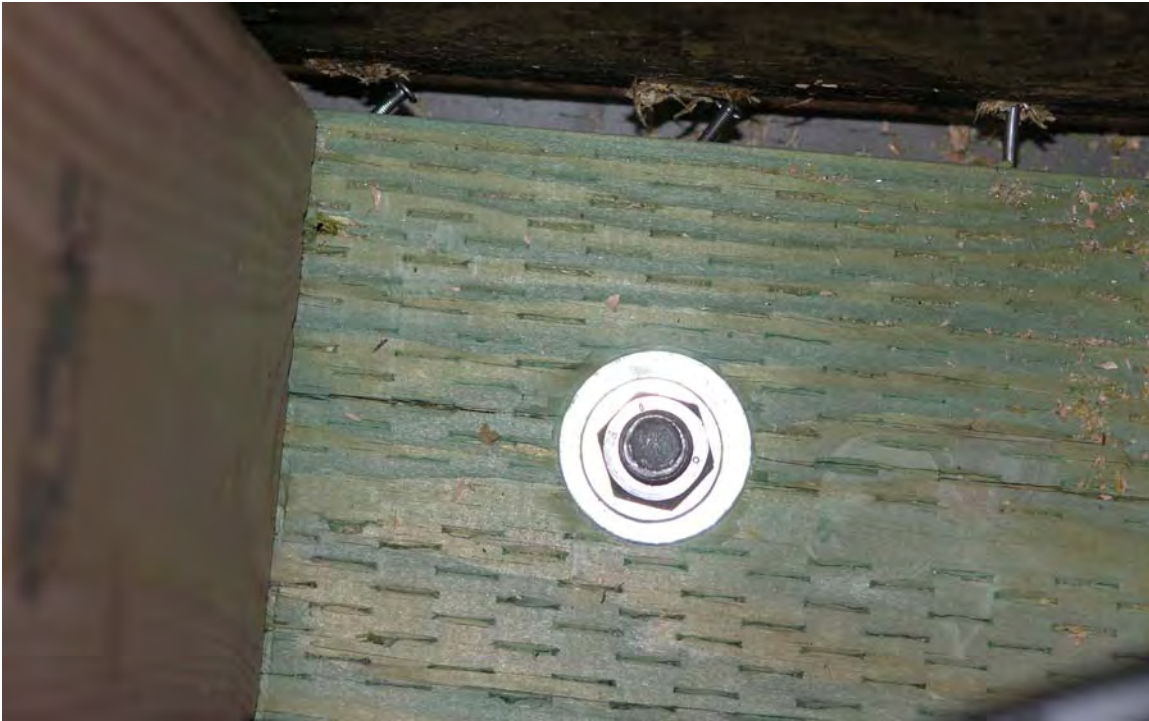
Figure 9. Splitting of bottom plate and separation of sheathing (Wall E2)

Wall designation	Washer type	Notes/observations:	Dominant failure mode
E1	Round Washer	Separation of sheathing from end studs and some interior studs. Some splitting of bottom plate along narrow face at the ends of the wall.	Fastener failure
E2		Separation of studs from top plate at corners of wall. Separation of sheathing material from studs predominately around the perimeter. Some splitting of bottom plate occurred starting at hold-downs at both ends.	Fastener failure
E3		Separation of double top plate from double end stud at top right corner of wall. Interior and center studs lifted up from bottom plate during testing. Splitting of bottom plate along its length. Sheathing material completely separated from double end studs at right end of the wall.	Fastener failure
F1	3" square plate washer	Separation of studs from double top plate at ends. Interior and center studs lifted up from bottom plate. Sheathing pulled away from end studs and bottom plate. Splitting of bottom plate that started along narrow face and extended to approximately the edge of the plate washer on the wide face.	Bottom plate failure

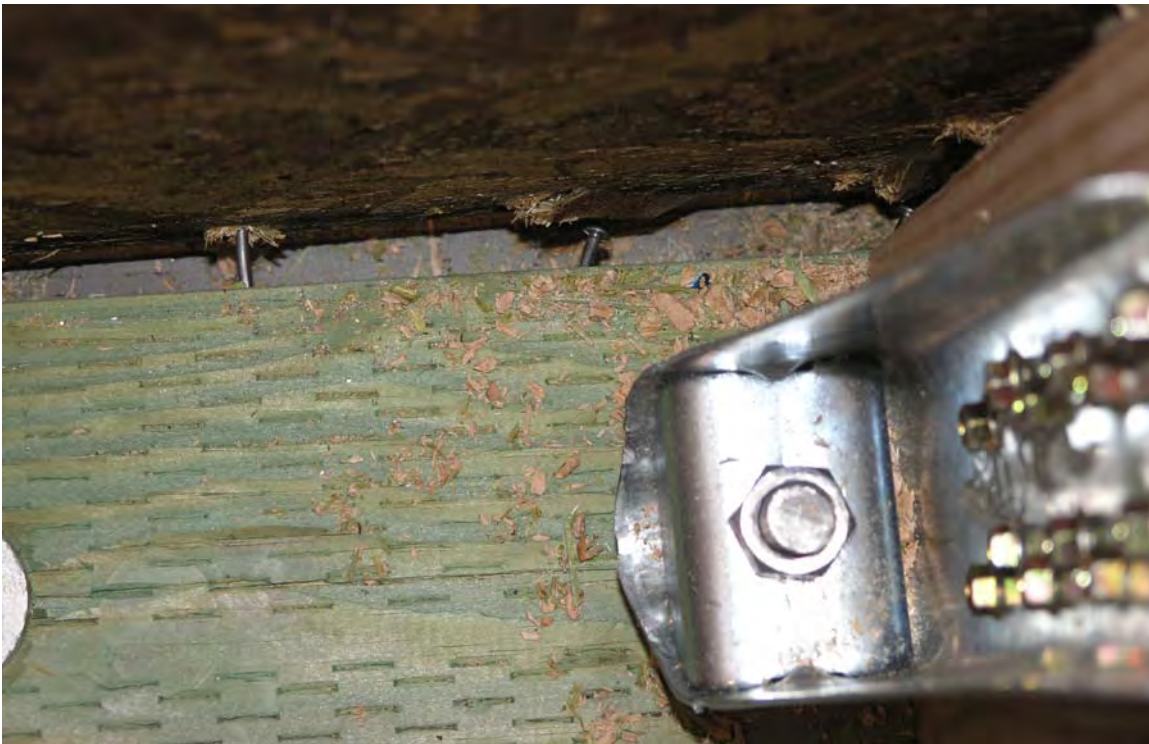
Figure 10. Splitting of bottom plate and separation of sheathing (Wall E2)

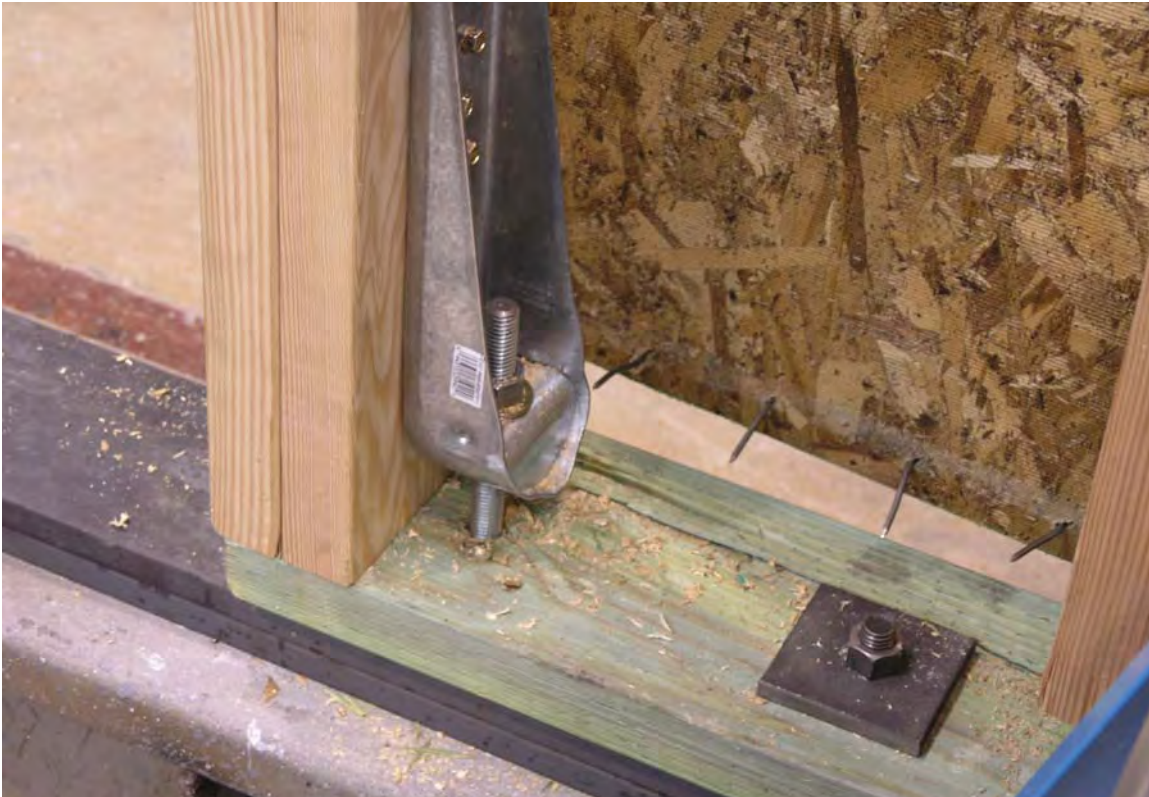
Figure 11. Separation of sheathing and splitting of bottom plate (Wall F1)

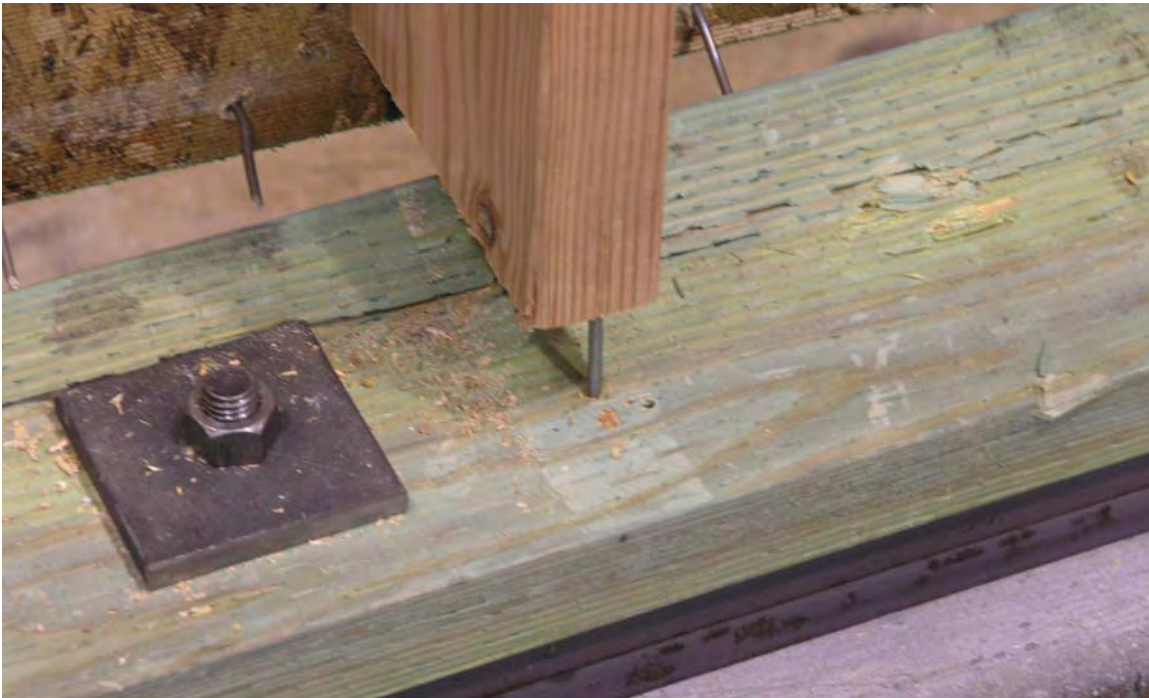
Figure 12. Splitting of bottom plate to the outside of square plate washer (Wall F1)

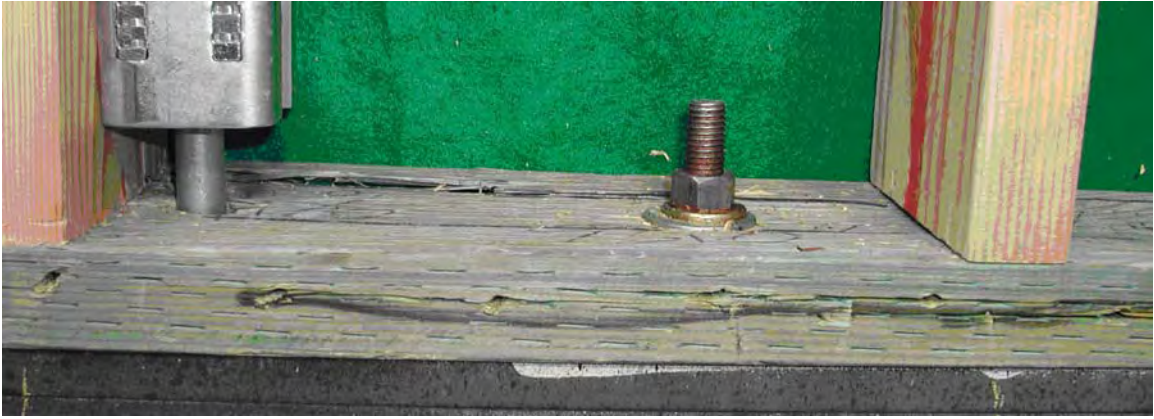
Figure 13. Splitting along narrow face on west side of wall (Wall G2)

Wall designation	Washer type	Notes/observations:	Dominant failure mode
G1	Round washer	Nails pulled completely out of OSB along bottom edge of the wall. Yielding of nails connecting two center studs together. Splitting along the narrow face of double end stud at south end of wall. Splitting in bottom plate mainly due to tension across the grain on the narrow face.	Bottom plate failure (splitting)
G2		Nail withdrawal along bottom edge of the wall. Separation of inter-nailed center studs. Splitting along the narrow face of center stud.	Bottom plate failure (splitting)
G3		Nail withdrawal along bottom edge of the wall. Splitting in bottom plate due to both tension across the grain on narrow face and cross grain bending on wide face of bottom face.	Bottom plate failure (splitting)

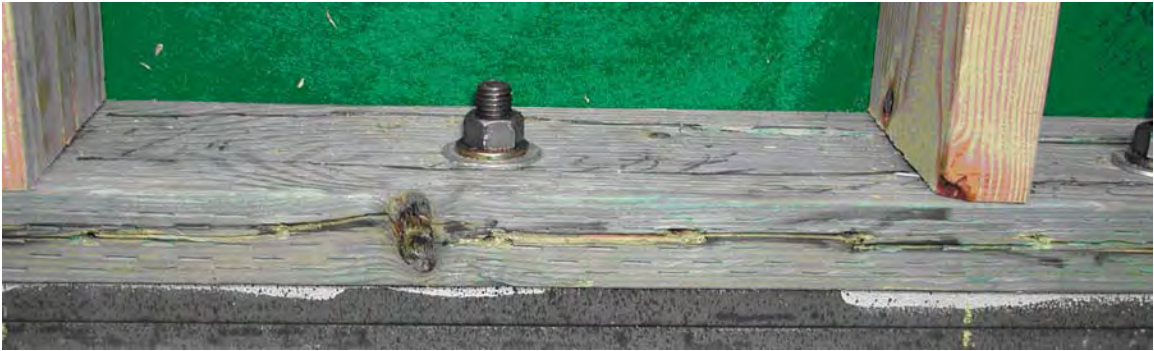
Figure 14. Splitting along narrow face on west side of wall (Wall G2)

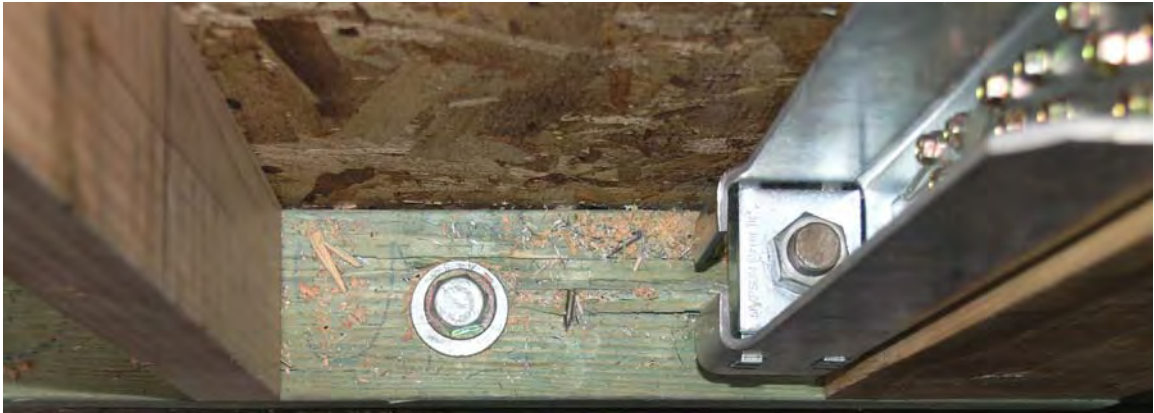
Figure 16. Splitting of bottom plate (Wall H1)

Wall designation	Washer type	Notes/observations:	Dominant failure mode
H1	Round washer	Double top plate split along narrow face and completely separated from wall. Also observed splitting along center stud of the wall. Some minor splitting in the bottom plate was also observed.	Splitting of center stud and top plate
H2		Data not available due to construction defect	
H3		Studs lifted up from the bottom plate at the ends. The threads of the holddown anchor bolt at the north end of the wall failed resulting in significant uplift and the corner and subsequent splitting of the bottom plate plate.	<ul style="list-style-type: none"> - Failure of threads on holddown anchor bolt - Bottom plate failure (splitting)

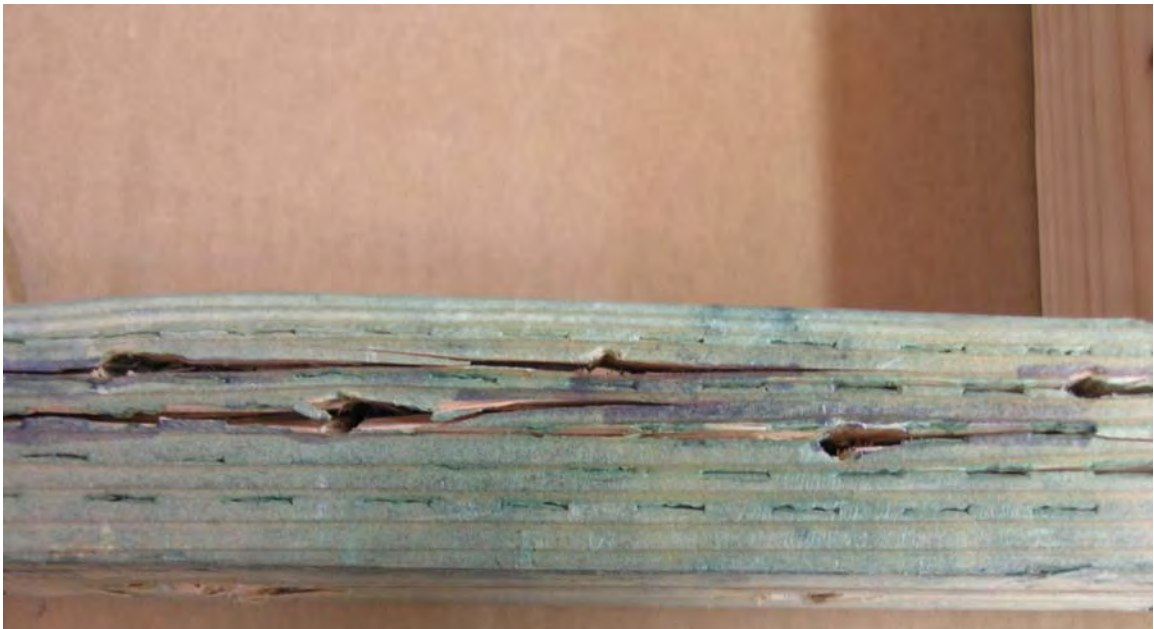
Figure 17. Splitting on narrow face of bottom plate (Wall H1)

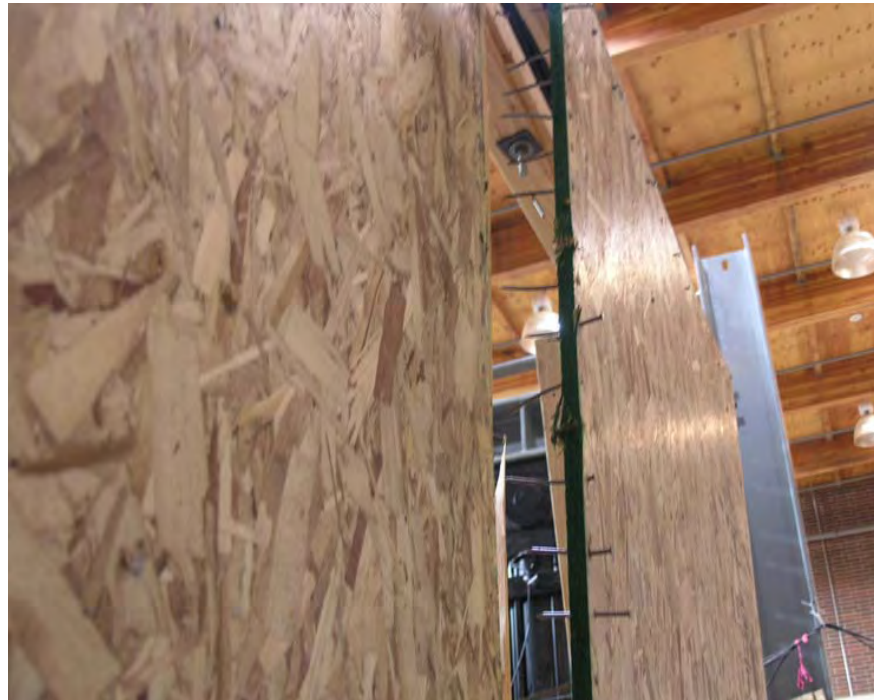
Figure 18. Slight yielding of nails around the perimeter (Wall H1)

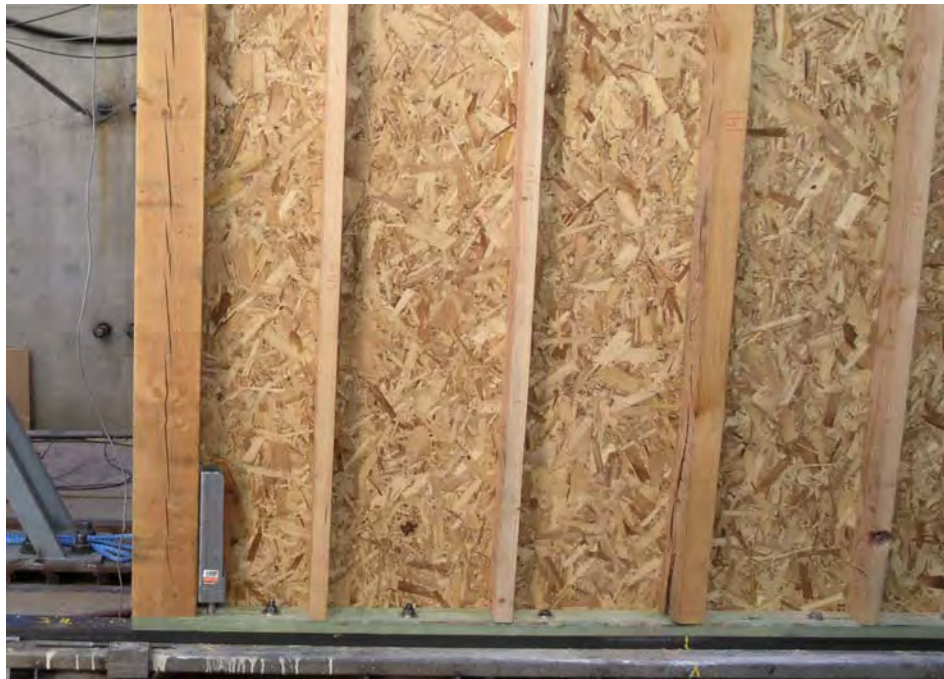
Figure 19. Wall H1 after testing.

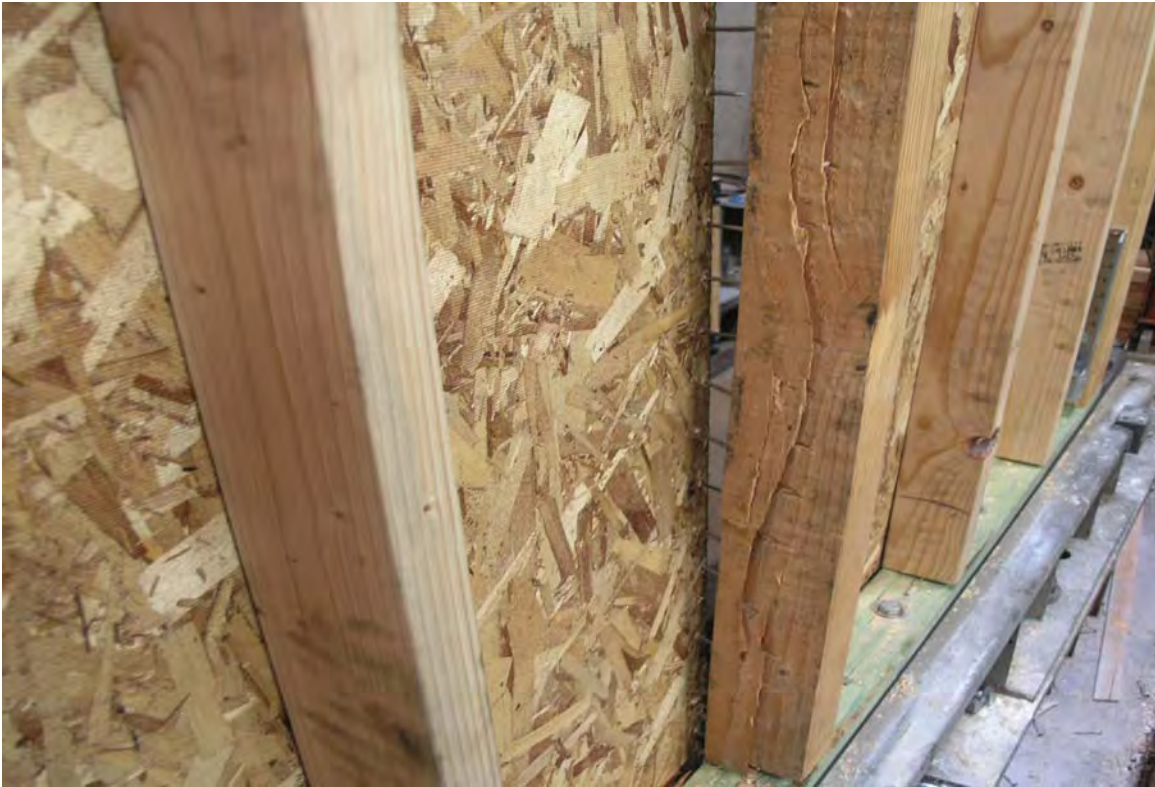
Figure 20. Splitting of center stud (Wall H1)
